Manhole Inspection Summary

Manhole # S11QQ1013MH

Insp Date: **5/13/09 3:29 PM**

Location Address: **4921 GARRISON AVE**

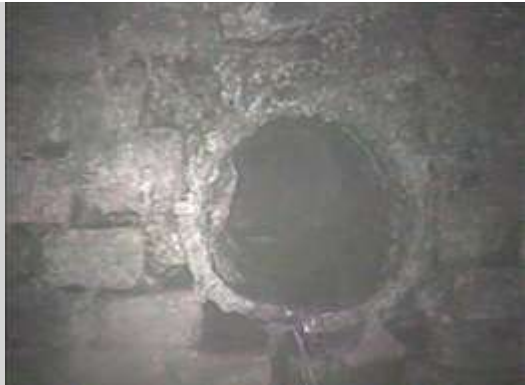
6 O'Clock Inflow

8 in. Circular Gravity Sewer

Pipe In @ 6 O'Clock

Pipe Height: (in.) Direct

Pipe Material: **Clay** ☐ Pipe Lined

Infiltration: **None** Pipe Seal Cond: **Sound**
